Connecting communities following the Lemons Hill slip

NO ORDINARY SLIP

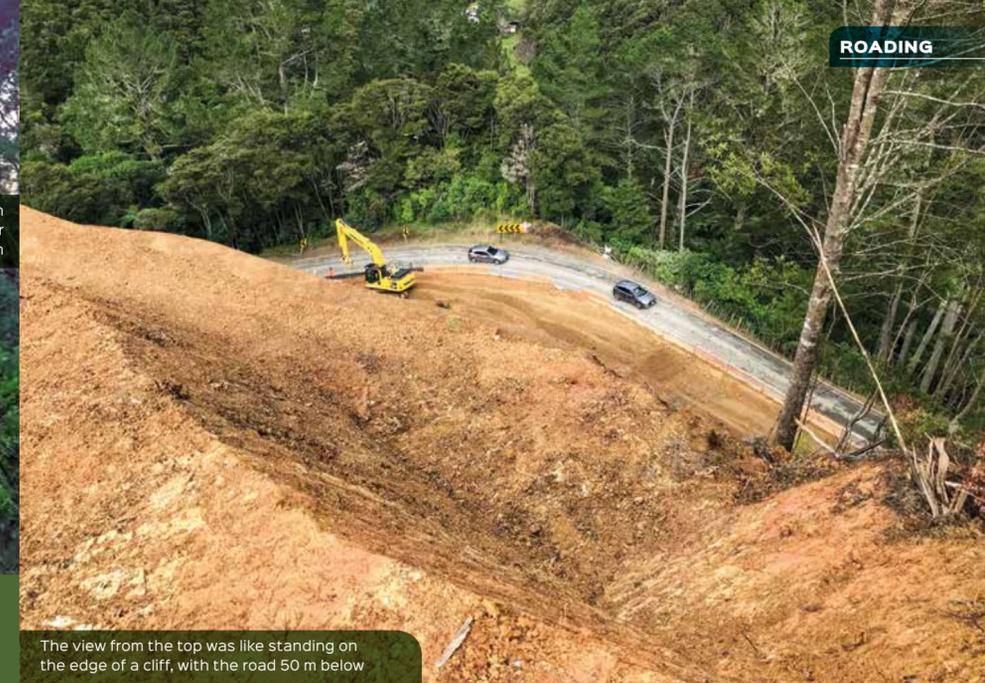
The view from the top was like standing on the edge of a cliff, with the road 50 m below
